NAVAL POSTGRADUATE SCHOOL

THESIS

**CORROSION AND THERMAL PROCESSING IN COLD
GAS DYNAMIC SPRAY DEPOSITED AUSTENITIC
STAINLESS STEEL COATINGS**

June 2016

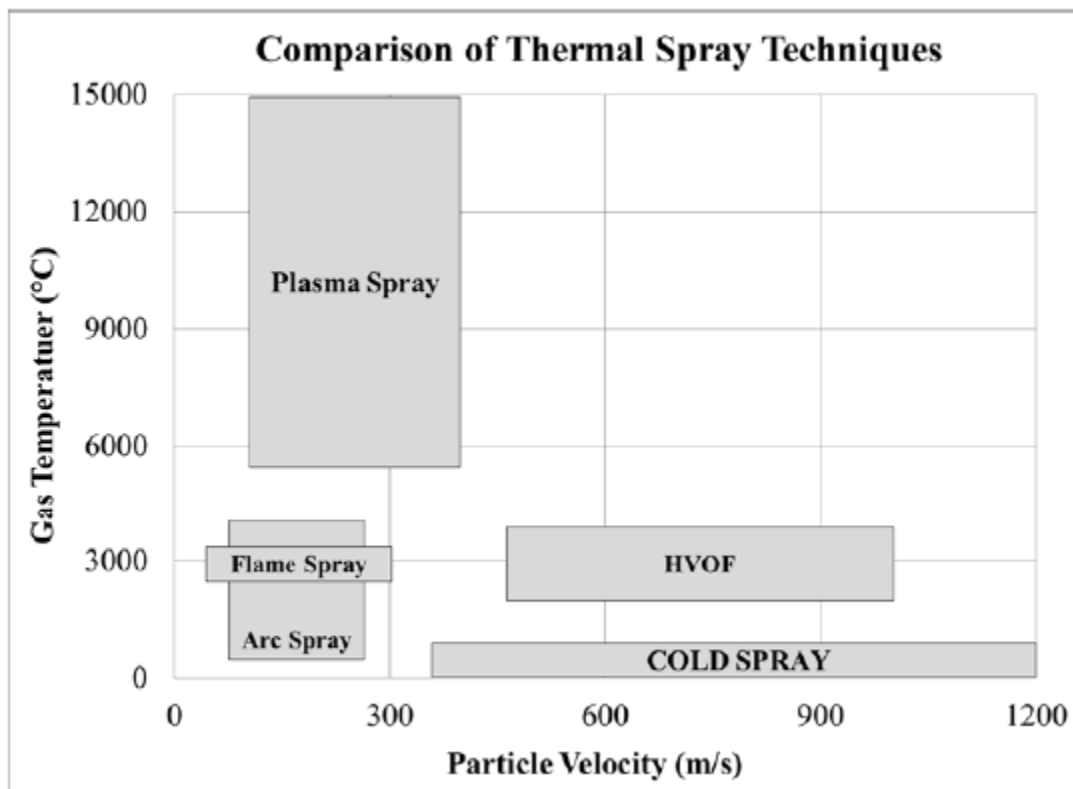
Figure 1. Comparison of general temperature and particle velocity range for coating spray techniques. Source: [3].

volatile elements, thermal stresses in the coating and oxidation or property changes in the coating and/or substrate materials due to high temperatures [2]. When conducted correctly, the cold spray process also gives a more dense coating due to a plastic peening effect from succeeding particles impacting on the applied coating and from the lack of a “splashing” effect that occurs with the impact of liquid or nearly liquid droplets [2]. The range of application temperatures and velocities used in the cold spray technique as compared to other coating spray technologies is shown in Figure 1.

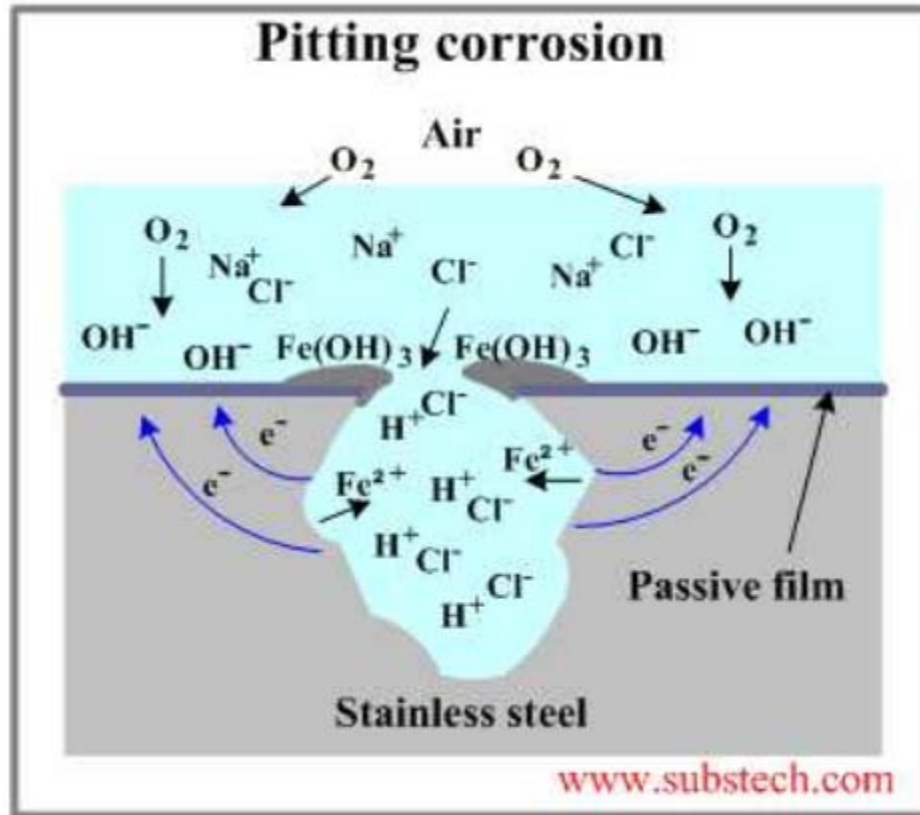
Figure 3. Schematic mechanism of pitting corrosion. Source: [29].

Stainless steels are characterized as a steel alloy having at least 10.5 wt% chromium added [27]. The additional chromium promotes the formation of a passive surface layer and gives a material with generally excellent corrosion resistance. However, stainless steels are susceptible to other specific corrosion modes, notably pitting, crevice corrosion and stress corrosion cracking [28]. Pitting and crevice corrosion are both forms of localized corrosion damage resulting from a similar mechanism. At its heart this is a failure of the passivation layer. Chlorine ions cause a local breakdown of the passive film leading to the nucleation of a pit. Local corrosion then leads to deaeration of the water thus forming a local acidic solution and anodic region. The surrounding water becomes alkaline by cathodic reduction of dissolved oxygen and allows the surrounding metal surface to act as an anode. Once a pit is established it forms a sheltered local environment where ferrous ions resulting from the anodic corrosion reaction can react with chlorine ions dissolved in the water to produce ferrous hydroxide and hydrochloric acid. This mechanism for acid production in turn decreases the local pH in turn produces more favorable conditions for galvanic corrosion [26]. This is shown schematically in Figure 3.

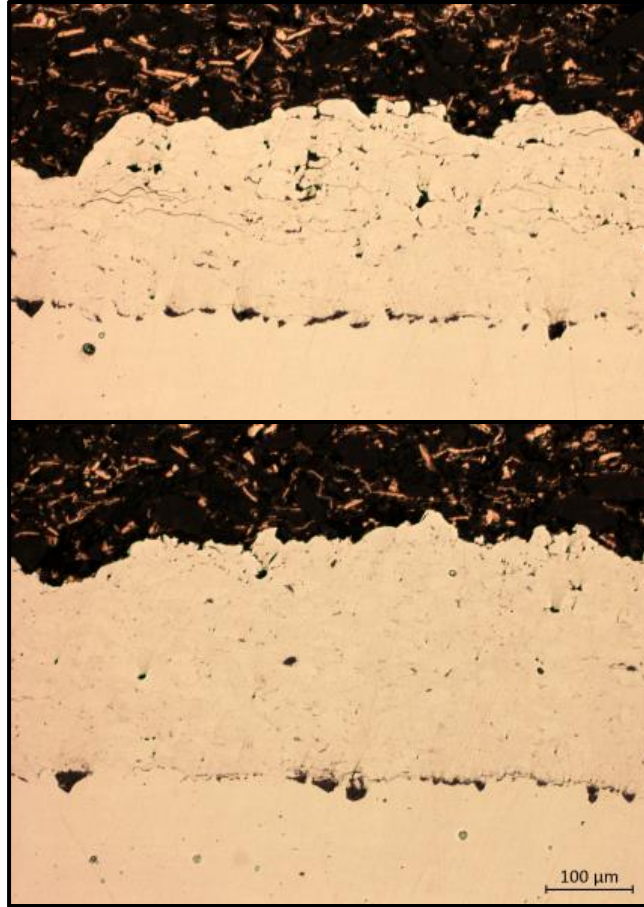
Figure 6. Typical micrographs of PG-AMP-10 powder sprayed with N_2 gas at 1.7 MPa and 450°C showing improved coating quality (decreased porosity) at 40 mm standoff distance. 16 mm standoff (top); 40 mm distance (bottom)

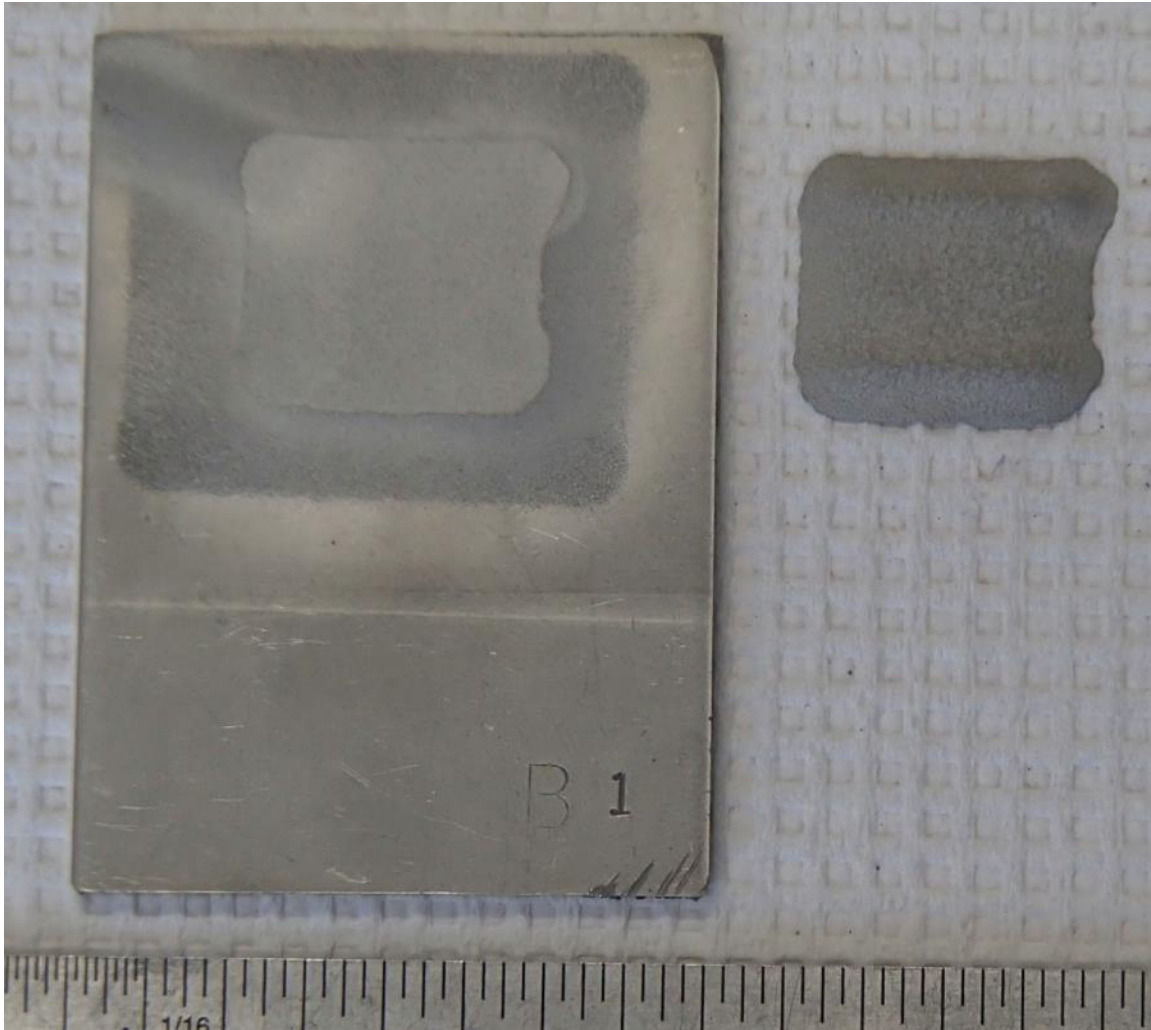
Figure 7. Coating detachment phenomena observed during spraying of 3rd pass with 5001 powder. He gas, 1.7 MPa at 230°C

In several instances the spraying of an additional layer on a previously well adhered coating was observed to result in the entire coating detaching from the substrate. An example of this phenomena is shown in Figure 7. The sample illustrated is using the 5001 powder with helium gas, however complete detachment was also observed with PG-AMP-10 powder and N₂ gas on the 4th pass. Additionally, multiple other samples exhibited partial detachment where the coating was only attached on one side of the deposit. Partial detachment was observed in samples of all 3 powders. Schiel also reports observing a similar phenomenon during some of his N₂ test sprays. No systematic investigation was conducted, however the general trend observed is that this is primarily associated with a thicker multiple pass coating. The detachment of the coating consistently happened during the spraying operation and no external mechanical force was involved—the coating detachment occurs solely as a result of stresses resulting from the particle impact or thermal effects.

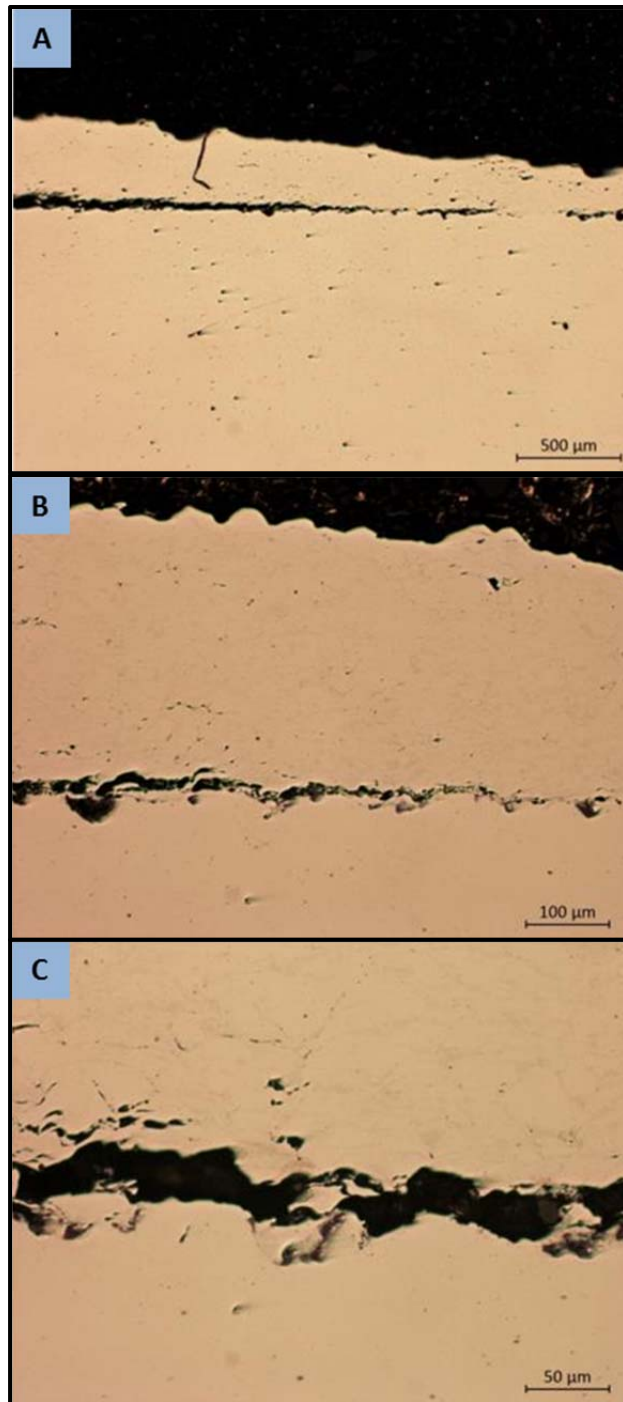
Figure 8. Coating detachment phenomena observed in 5002 powder sprayed with helium gas at 1.7 MPa, 230°C. Increasing magnification (a) to (c).

detachment occurring over a large area and resulting in the entire coatings being completely detached from the substrate. The evidence of a force pulling the coating off the substrate suggests that the ultimate cause is a tensile stress in the coating at the substrate/coating boundary. Work conducted on residual stress in cold spray coatings [33, 34] shows that compressive residual stress is found in the coating surface, and a tensile residual stress is common at the coating/substrate boundary; however the magnitude of this stress appears to be dependent on the exact spray parameters used and the substrate/coating material. Notably, results reported in the available literature focus on aluminum and copper coating with no data available on stainless steel coatings. Further investigation is warranted to measure the residual stress in low pressure cold spray stainless steel coatings and determine mitigation measures to prevent the coating detachment problem observed. This problem would prevent the application of a reliable high quality coating and hence makes practical application of the process very difficult. Residual stress studies could show if the ultimate problem is high residual stress in the coating or low bond strength. If the problem lies in a high residual stress then it is possible that a stress relief heat treatment between coating passes could alleviate this problem.

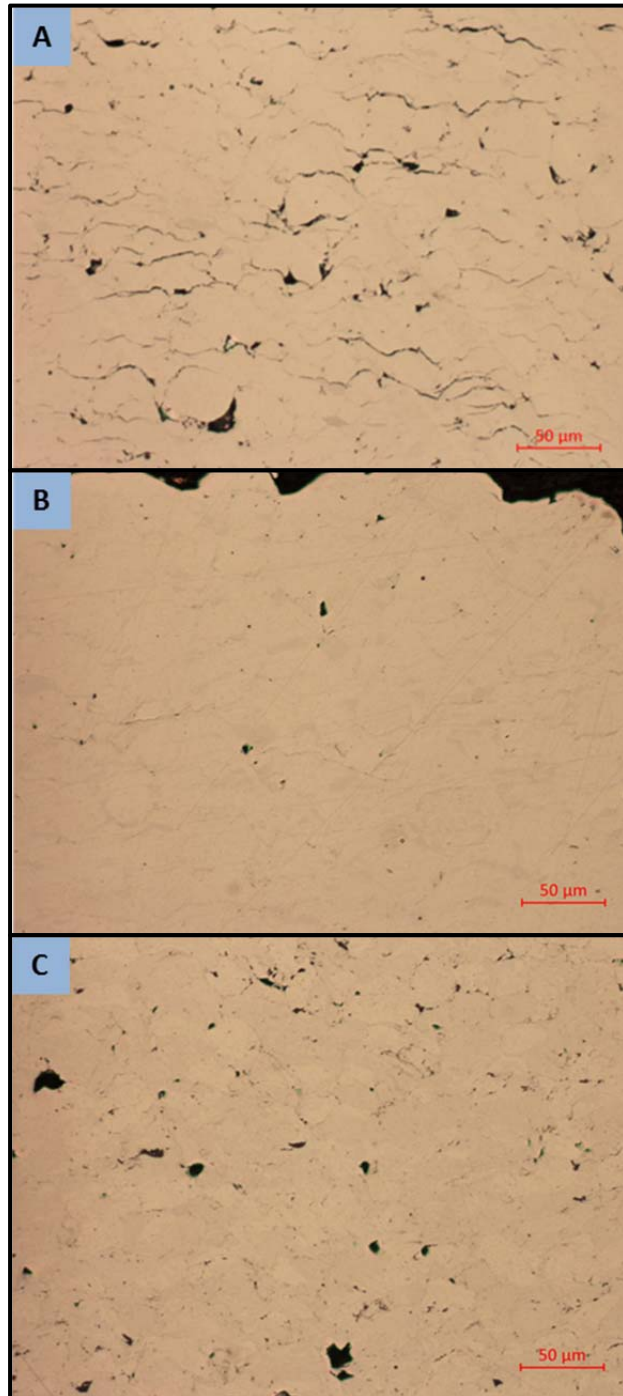
Figure 9. High magnification optical micrographs of as-sprayed coatings showing qualitatively dense coating structure with limited porosity. (a) 5001 powder; (b) 5002 powder; (c) PG-AMP-10 powder.

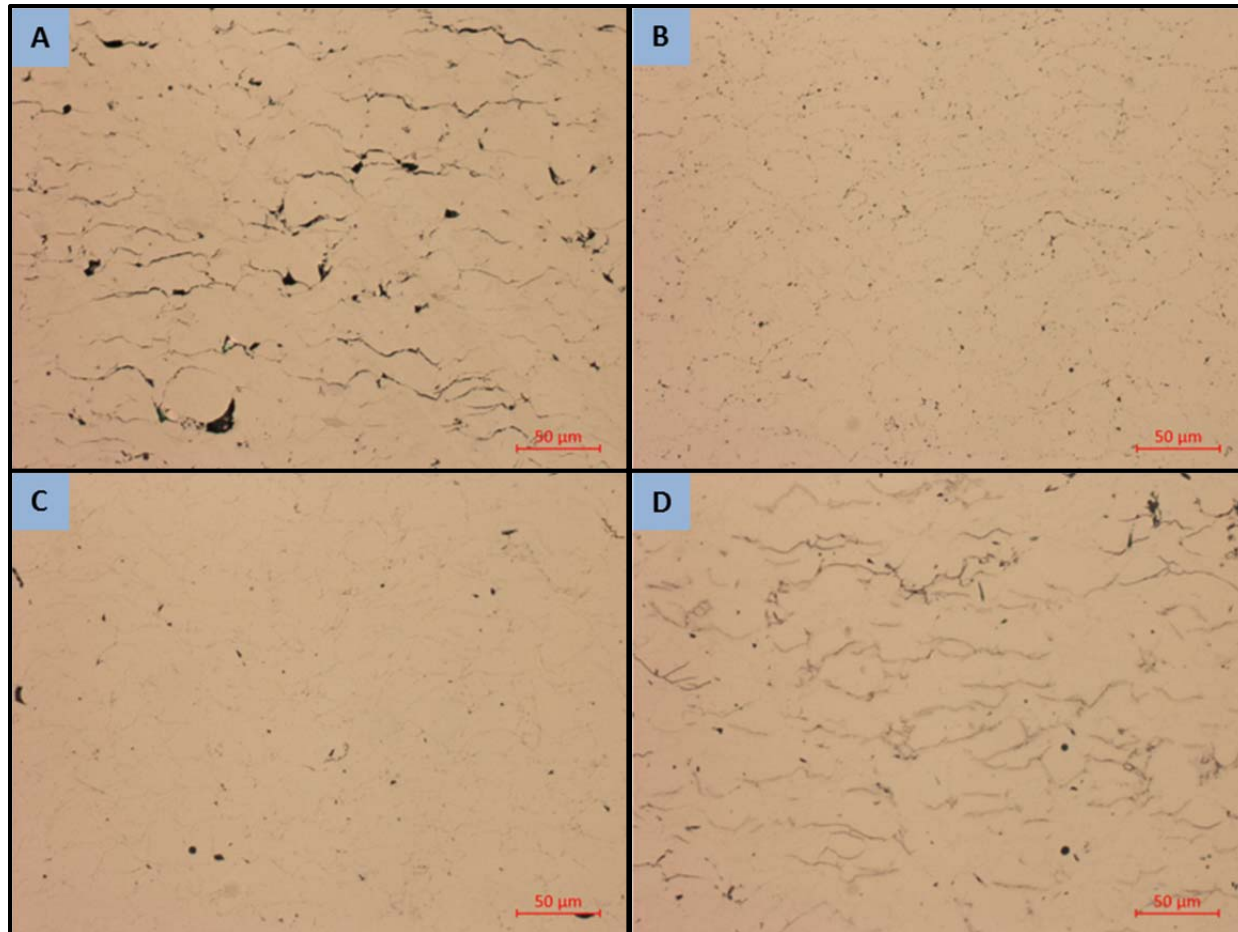
Figure 10. High magnification optical micrographs showing changes in porosity with heat treatment. 5001 powder. (a) as sprayed; (b) 950°/1hr; (c) 800°C/2hrs; (d) 600°C/8 hrs.

The most visible change resulting from heat treatment is in the sample porosity. The lowest energy state is a complete absence of porosity, so the trend is expected to be towards reduced porosity as diffusion rates increase with temperature. Since the complete elimination of porosity would require substantial large scale diffusion this is not likely. As an intermediate lower energy state, the consolidation of numerous smaller porous regions in single larger areas and the conversion of long thin regions to one or more spherical regions can be expected. This behavior is seen in the 5001 samples as seen in Figures 10 and 11. The lower temperature heat treatment shows a structure similar to the as-sprayed sample but in both the higher temperature samples the long thin regions of inter-splat porosity are seen to have consolidated into circular regions. With longer or higher temperature treatment, these would be expected to consolidate further to individually larger but less numerous regions. Similar results are seen in the 5002 and PG-AMP-10 powders as shown in Figures 12 and 13.

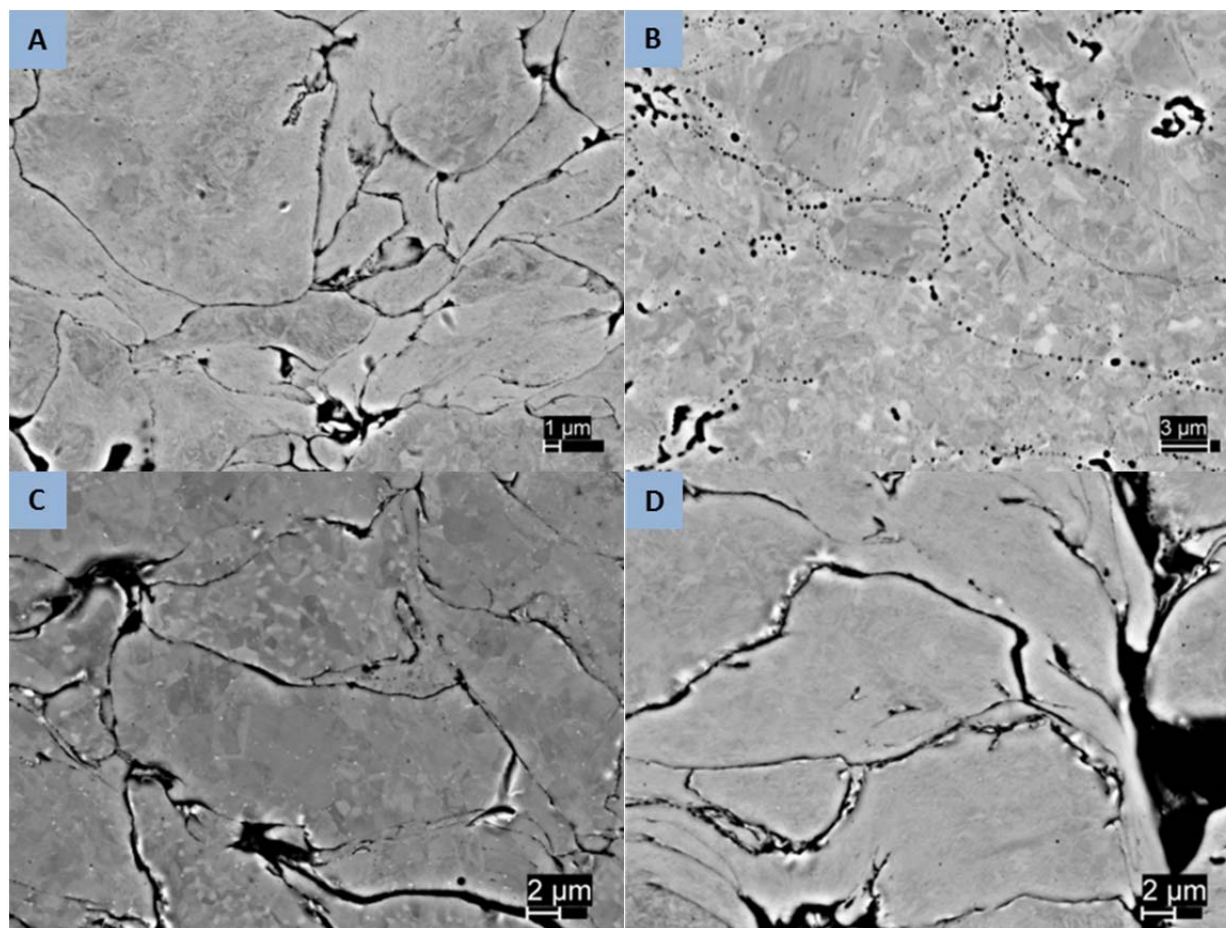
Figure 13. Backscatter electron images of PG-AMP-10 powder samples showing porosity reduction following heat treatment. (a) as sprayed; (b) 950°/1hr; (c) 800°C/2hrs; (d) 600°C/8 hrs.

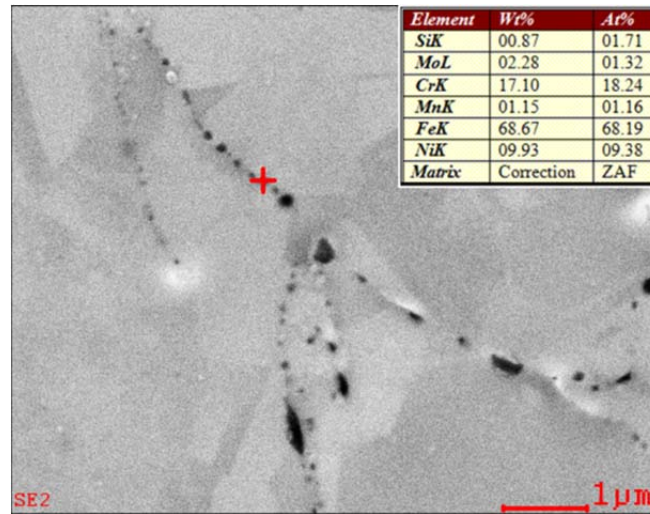
Figure 14. Typical point EDS measurement of possible precipitate.

In the 950°C/1 hr micrographs small circular dark regions are observed that seem to correspond to inter-splat boundaries. These images were taken using the backscatter detection mode to enhance contrast, however this also has the effect of making it difficult to determine if dark regions are porosity in the sample or precipitates with a lower atomic number than the bulk material. In order to further identify these, high magnification EDS scanning and secondarily electron imaging was conducted in these regions. No evidence of elemental concentration was seen in EDS scanning which suggests that these areas are porosity rather than precipitates. A typical point EDS measurement is shown in Figure 14. In this case, the chromium content is observed to actually be less than the overall coating composition (Table 9).

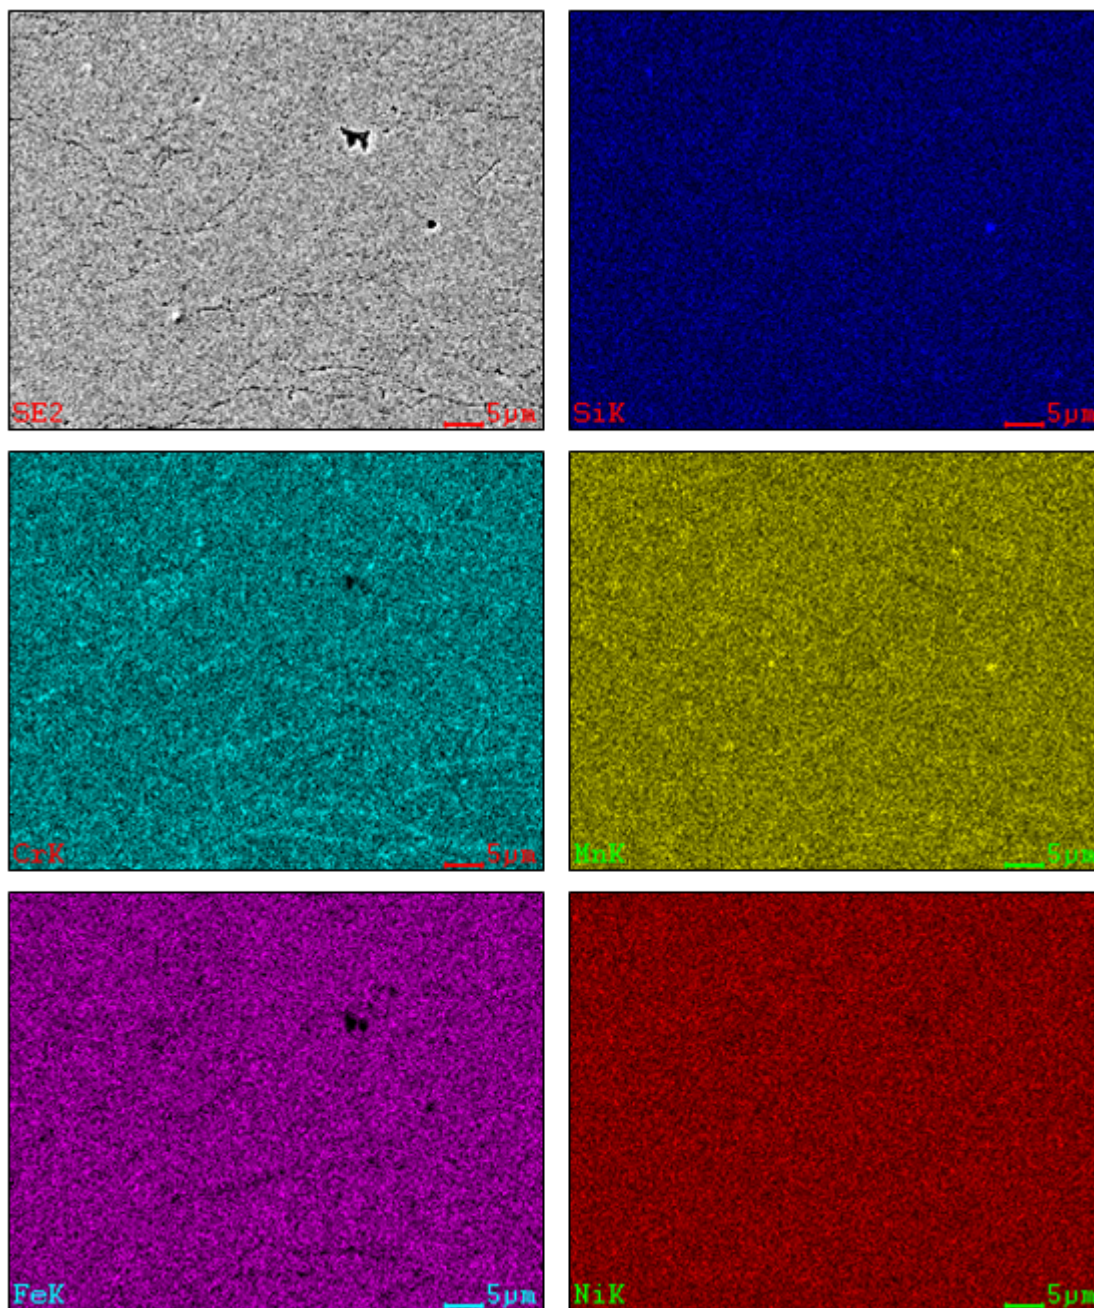
Figure 16. Typical EDS elemental distribution map. 5001 powder, 600°C/8hrs heat treatment.

While the overall composition is relatively constant, the elemental distribution may change with heat treatment due to solid state diffusion resulting in undesirable phase changes, precipitates or depletion of necessary alloying elements and thus changes in the bulk material properties. Of the alloying elements in stainless steels, chromium is perhaps the most important since it is primarily responsible for the corrosion resistance of the material [27]. Molybdenum also has important benefits for pitting resistance in the 316 alloys (5002 and PG-AMP-10 powder) [27]. Chromium, molybdenum and silicon stabilize the ferrite phase in steels, while nickel and manganese stabilize the austenite phase [38]. Consequently, a change in the distribution of these elements may cause or be indicative of a change in the phase structure. This in turn is likely to effect the corrosion and mechanical properties of the material. The distribution of elements within the sample was determined by EDS mapping, with a typical set of elemental distribution maps shown in Figure 16. Complete maps for each sample are included in the appendix.

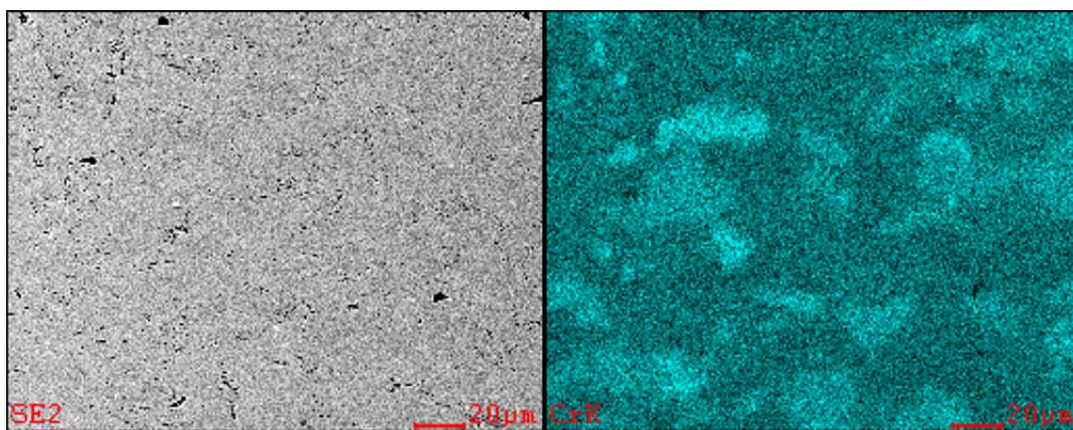
Figure 17. EDS map of as sprayed PG-AMP-10 powder showing chromium rich areas likely associated with ferrite phase grains.

The distribution of nickel, molybdenum and silicon was found to be relatively even and consistent for all of the powders and heat treatments. In all of the 5001 samples and the 600°C/8hrs heat treatment samples of 5002 and PG-AMP-10 no significant changes were evident in iron, chromium or manganese distribution. The PG-AMP-10 powder shows evidence of uneven chromium distribution in the as-sprayed condition as shown in Figure 17. Schiel reports similar uneven chromium distribution in the raw powder. [3]. The chromium rich areas seen here and in subsequent maps of the PG-AMP-10 powder likely correspond to the ferrite phase. In both the 5002 and PG-AMP-10 samples some evidence is seen of chromium and manganese concentration at particle boundaries in the 800°C/2 hrs and 950°C/1 hr heat treatments. This is most notable in the 5002 powders, and chromium shows the most striking change. This is illustrated in Figures 18 and 19.

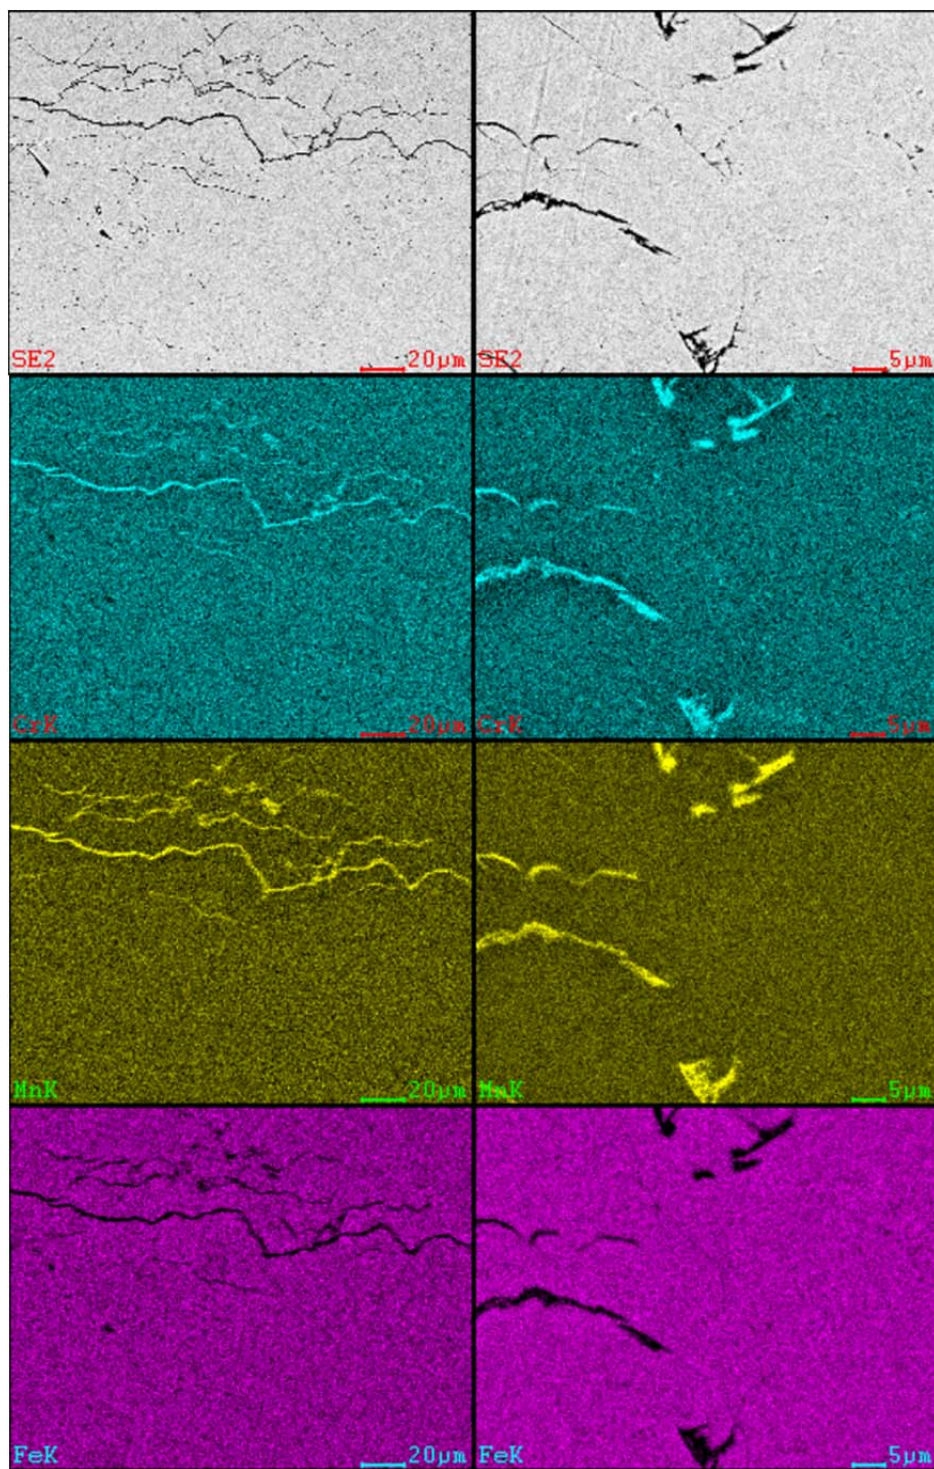
Figure 18. EDS maps showing evidence of elemental redistribution in 5002 powder, 950°C/1 hrs (left) and 800°C/2hrs (right). Note different scale.

It is notable however that the striking concentration noted in the 5002 maps shown in Figure 18 was not consistent. Maps were taken at both a high (1.5KX) and low (500X) magnification and in both the 950°C/1 hrs and 800°C/2hrs heat treatments of the 5002 a clear concentration was seen in one set of maps but not the other. Figures 20 and 21 show this occurrence. In both of these samples, the apparent concentration of the elements appears to be associated with porosity in the sample. There is also an apparent complete lack of iron in these regions. Taken together these facts suggest that the apparent concentration seen may be an artifact of the mapping process rather than evidence of an actual elemental redistribution. The PG-AMP-10 powder shows a similar concentration of chromium in porous regions but with more consistency between maps as shown in Figures 22 and 23. An apparent lack of iron in the apparent high chromium regions is seen in these samples as well however, suggesting the same EDS process artifact as is apparent in the 5002 data. Some apparent depletion of iron concentration is to be expected from an increase in chromium concentration, but this should show as a lighter region on the map, not a completely dark region. A large dilution of iron would have to occur to give the very low signal level associated with a completely dark region of the map and this seems unlikely from the apparent chromium increase. It should be noted however that there is also a distribution of chromium in the PG-AMP-10 powder that is likely associated with ferrite grains. These regions are the larger areas that show some apparent concentration of chromium with a lower concentration of iron. There are also regions showing a high concentration of chromium (brighter color) and a corresponding complete lack of iron and visual porosity; these regions are likely artifacts. This is illustrated in Figure 24.

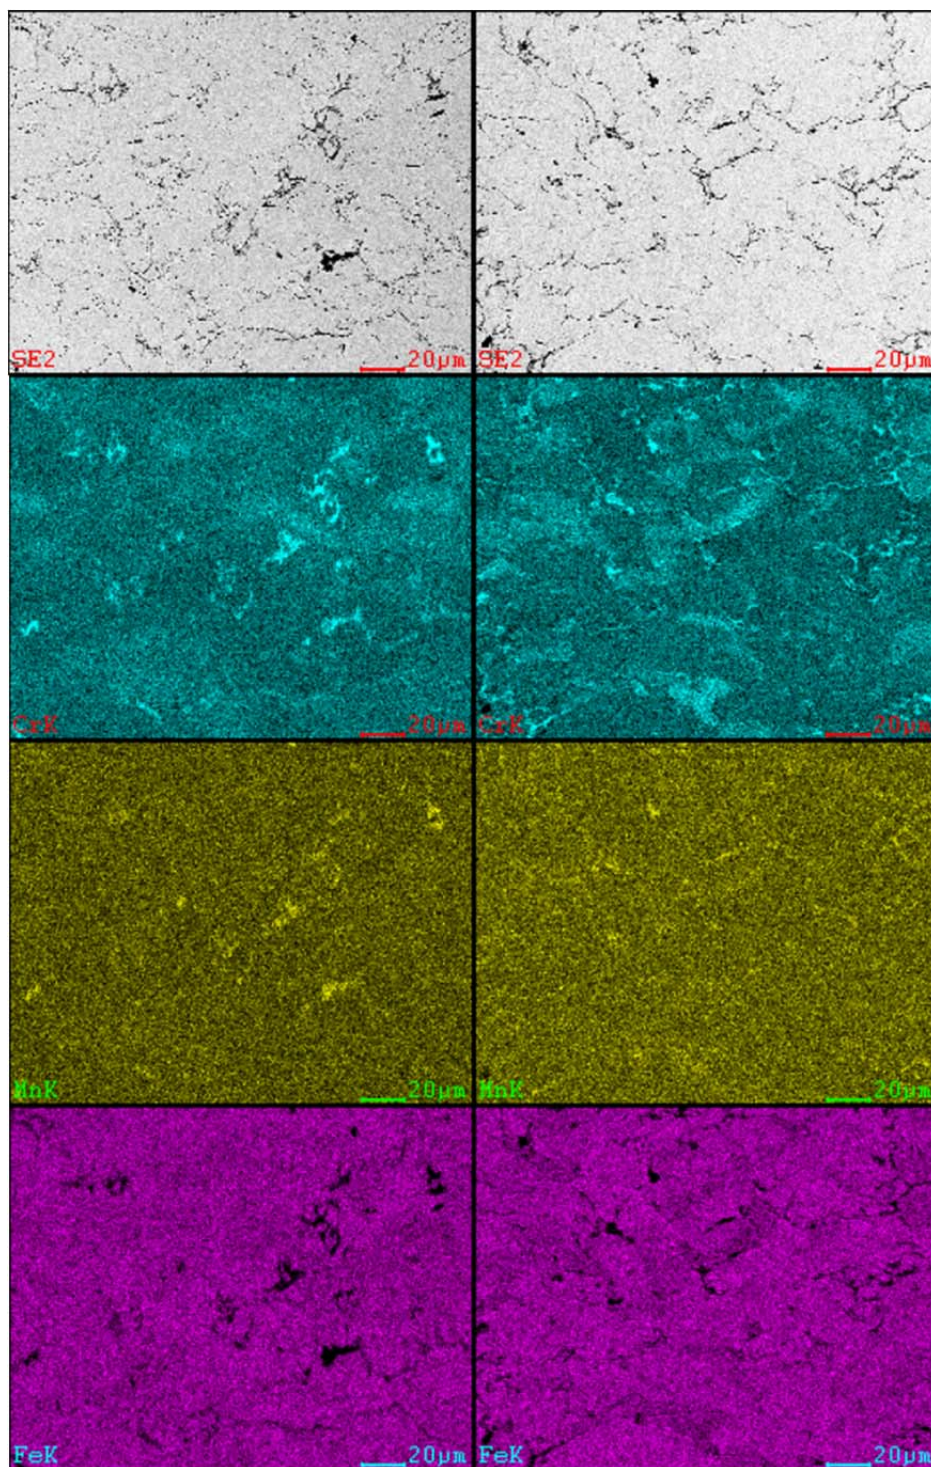
Figure 19. EDS maps showing evidence of elemental redistribution in PG-AMP-10 powder, 950°C/1 hrs (left) and 800°C/2hrs (right).

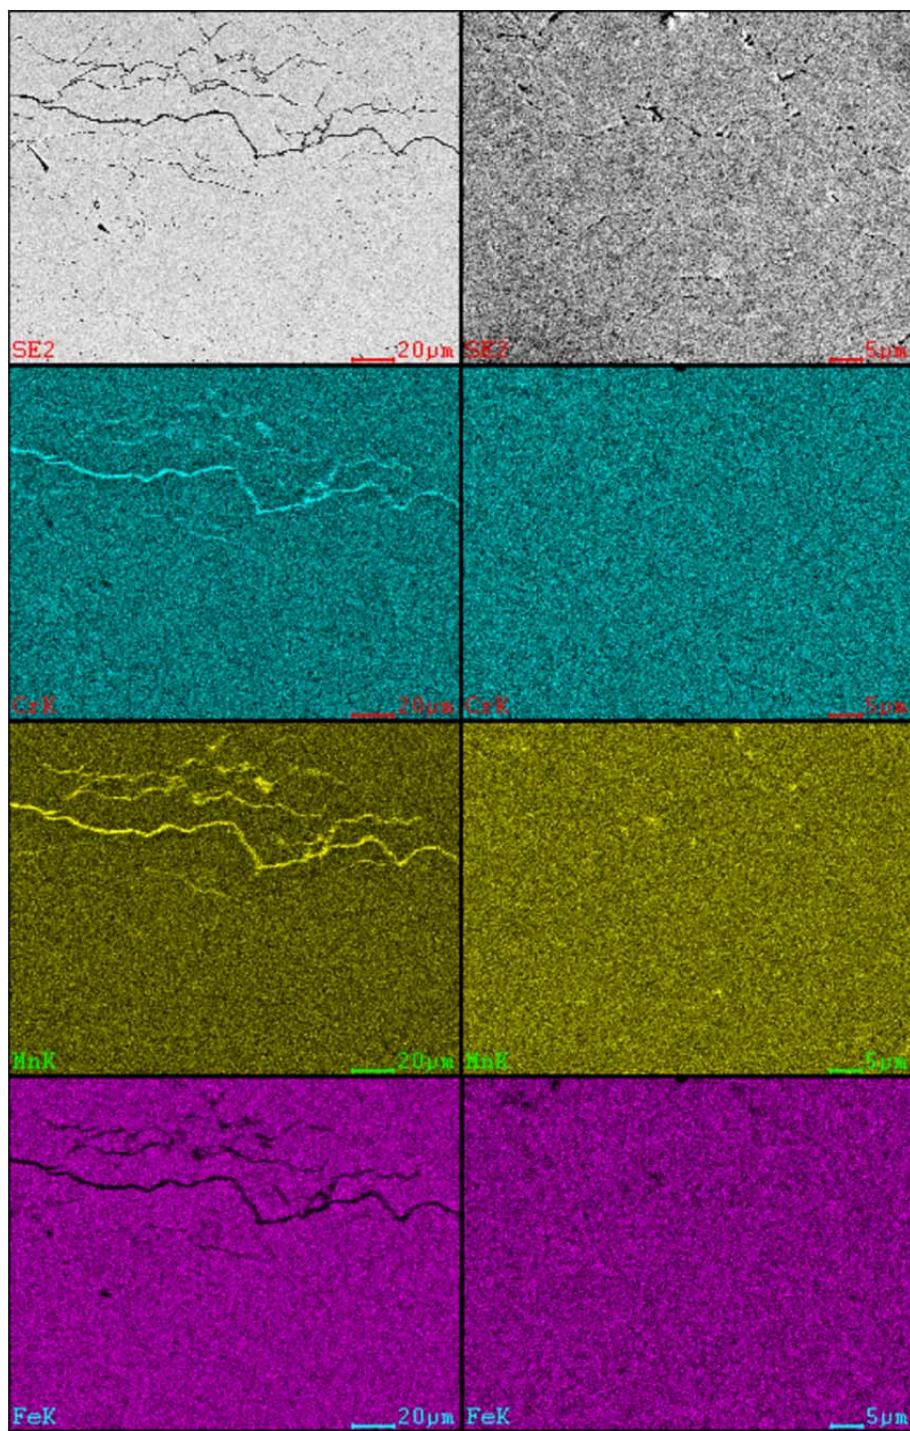
Figure 20. EDS maps of 5002 powder, 950°C/1 hr heat treatment at 500X (left) and 1.5KX (right) showing inconsistency in observed elemental distribution.

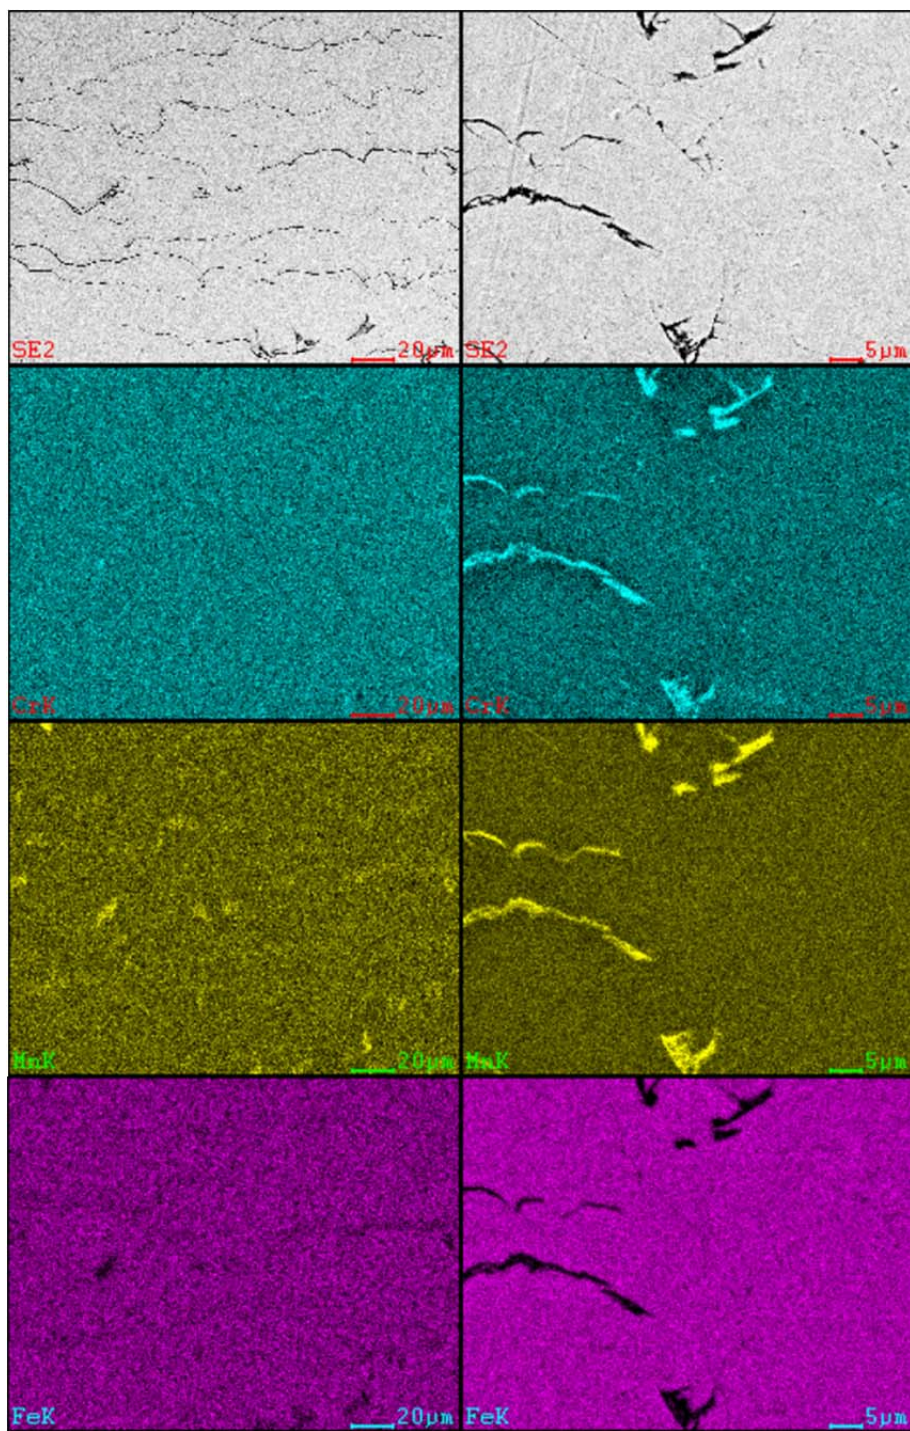
Figure 21. EDS maps of 5002 powder, 800°C/2 hrs heat treatment at 500X (left) and 1.5KX (right) showing inconsistency in observed elemental distribution.

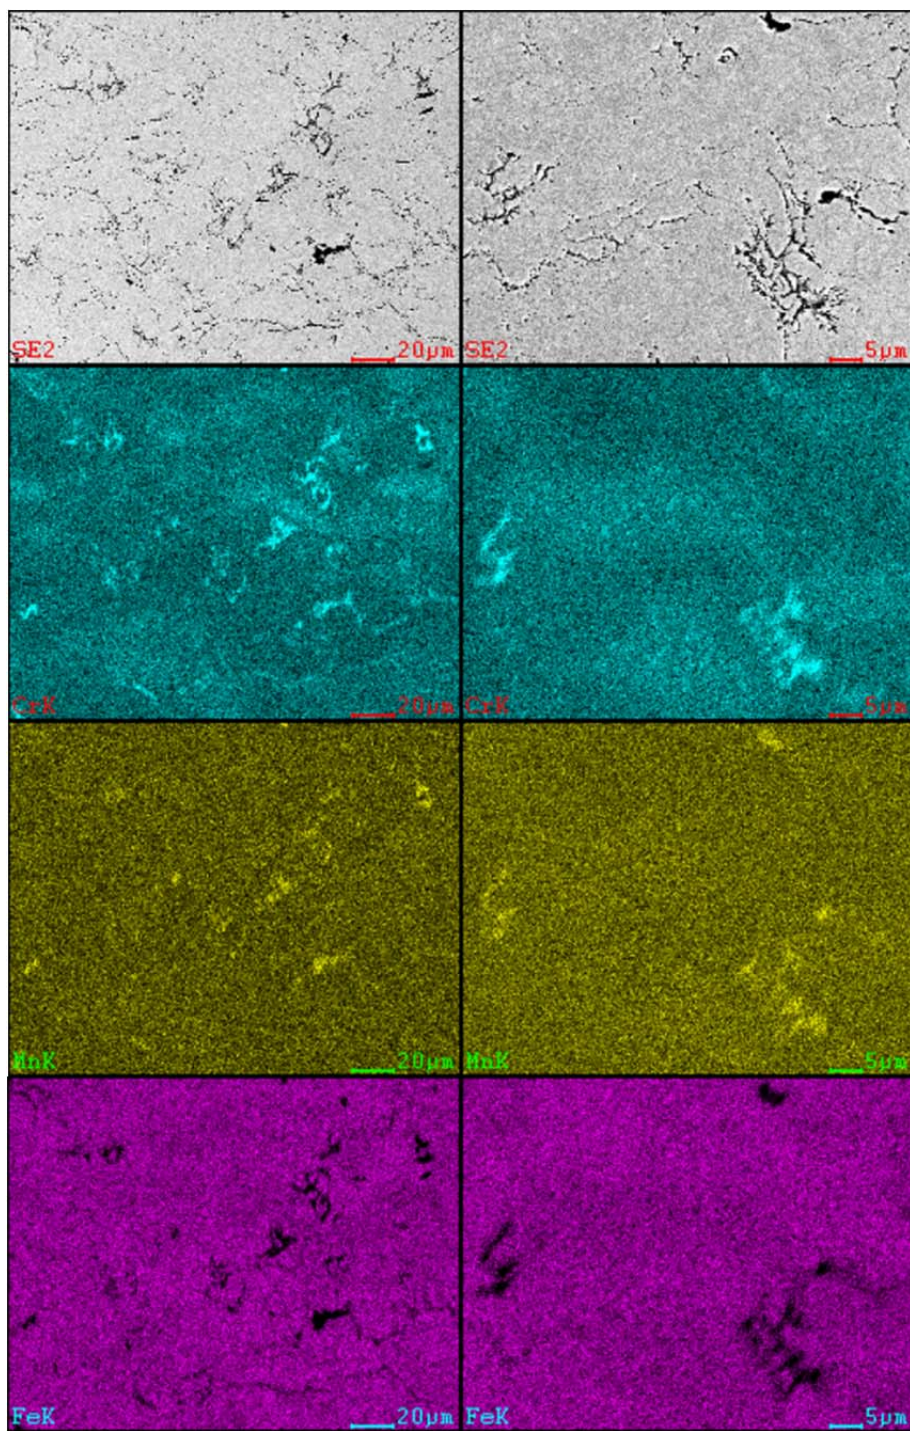
Figure 22. EDS maps of PG-AMP-10 powder, 950°C/1 hr treatment at 500X (left) and 1.5KX (right) showing inconsistency in observed elemental distribution.

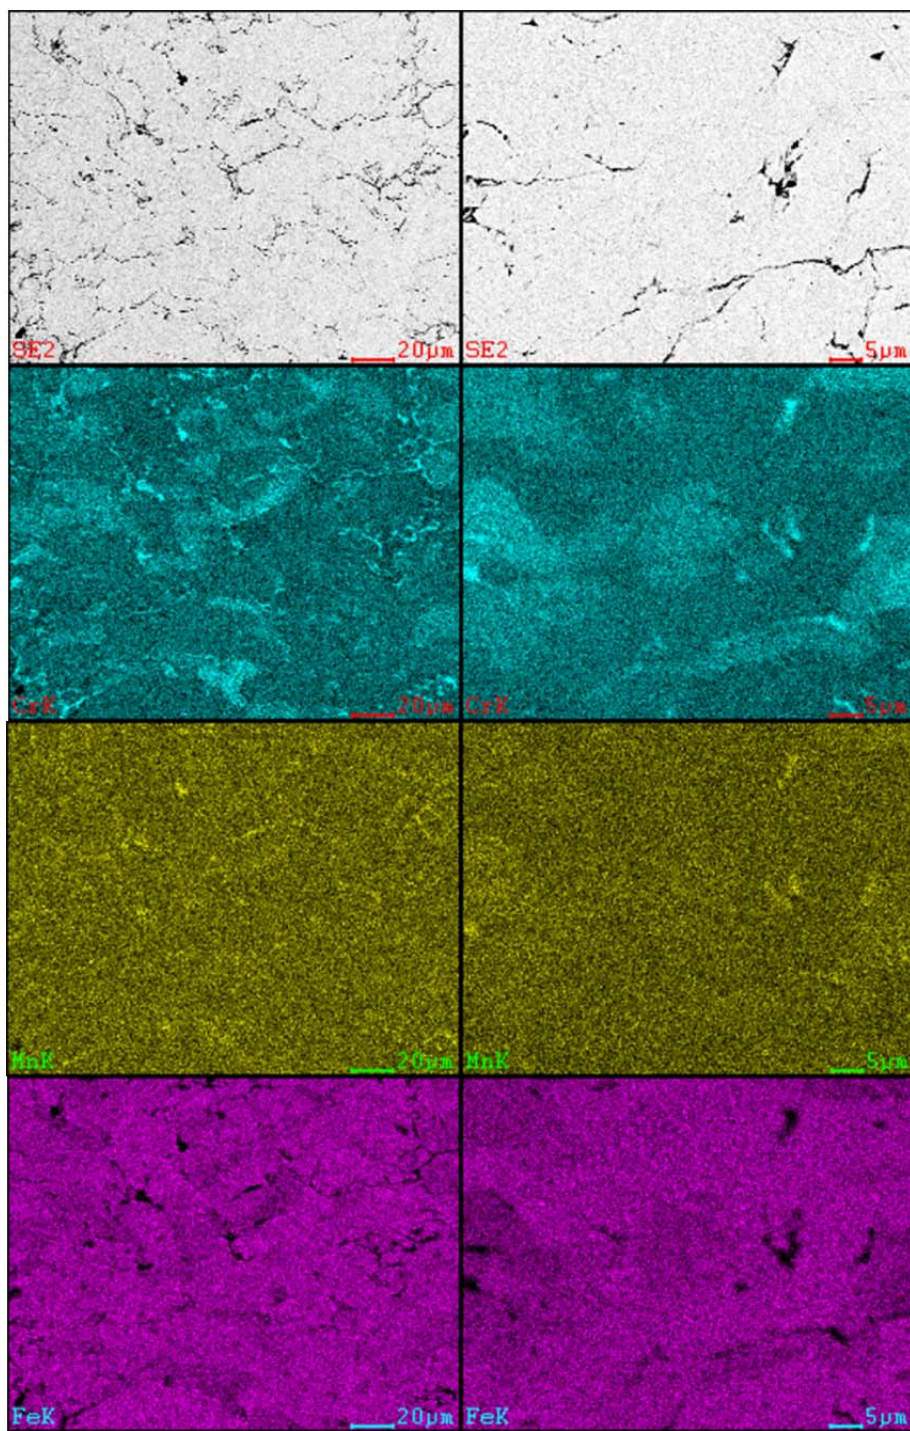
Figure 23. EDS maps of PG-AMP-10 powder, 800°C/2 hrs treatment at 500X (left) and 1.5KX (right) showing inconsistency in observed elemental distribution.

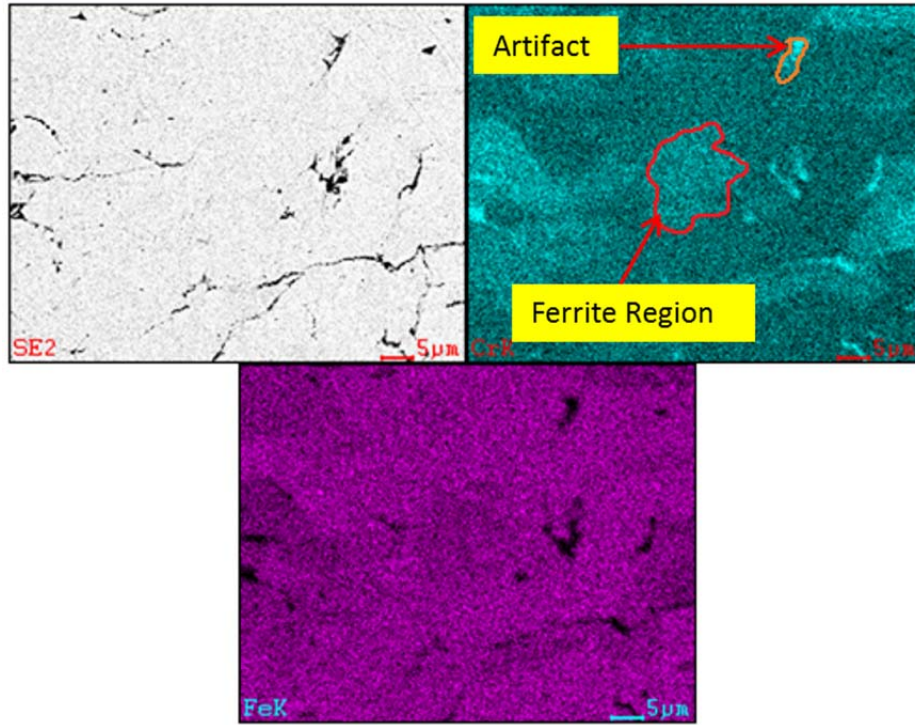
Figure 24. Chromium distribution in ferrite grains and process artifacts in PG-AMP-10 coating.

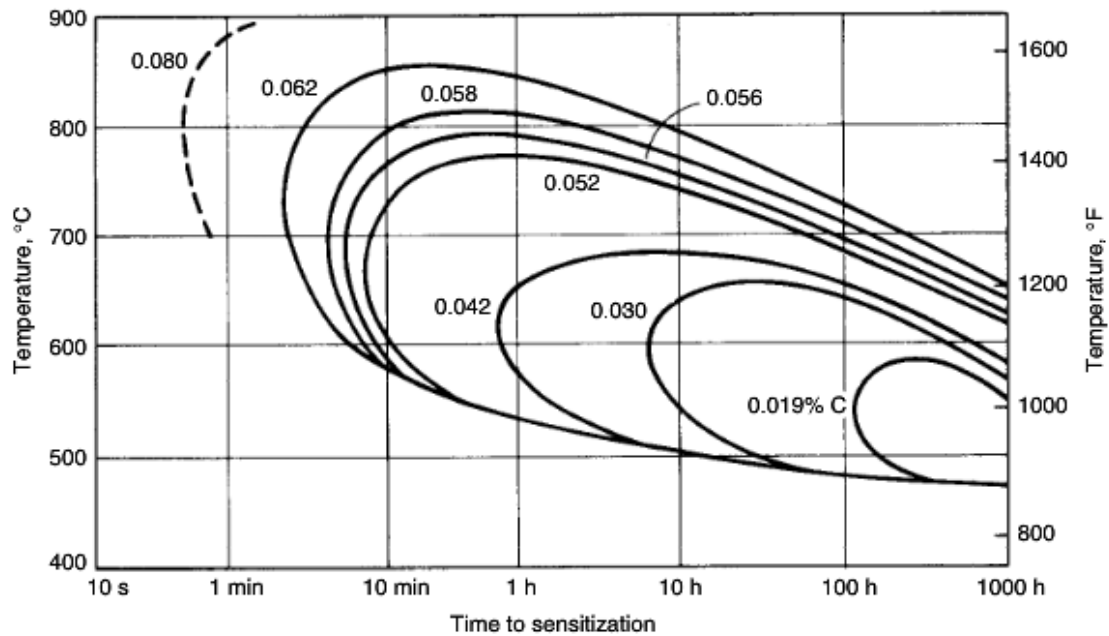
Figure 25. Time-Temperature sensitization curve for 304 stainless steel alloy with varying carbon contents. Source: [41].
